# WWTP maintains phosphate discharge compliance using Hach BioTectors

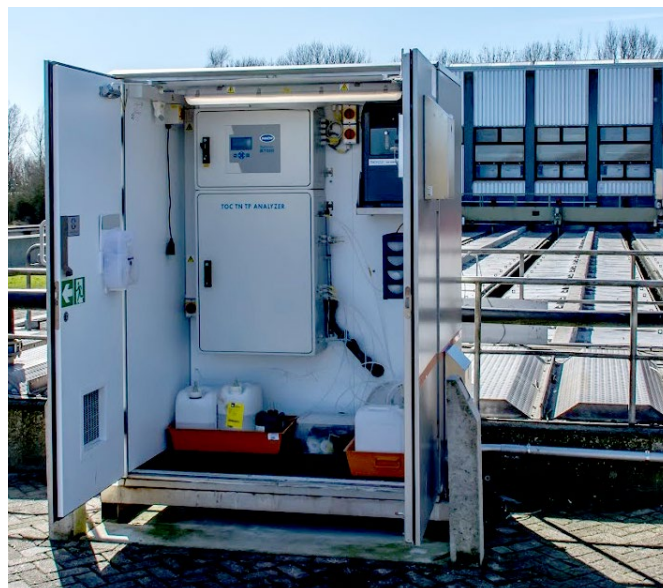
*Biotector unit at the Oijen WWTP*

The customer needed to know more about the composition of their influent and effluent wastewater. This resulted into the installation of a BioTector B7000 for reliable monitoring of their effluent streams for C, N, and P discharge.

The second phase involved gaining insight on C/N/P ratios hitting their wastewater influent, so a second BioTector B7000 (TOC/TN/TP) analyser was purchased. This unit reliably monitors the influent in real-time, and allows a rapid response to sudden composition changes, eliminating the significant costs of restoring the process after such a disturbance. Real-time data drives insights into whether there are problems with the process, or problems caused by external discharges.
